Working Report 2007-05

Search for Glacio-Isostatic Faults in the Vicinity of Olkiluoto

February 2007

Geological Survey of Finland

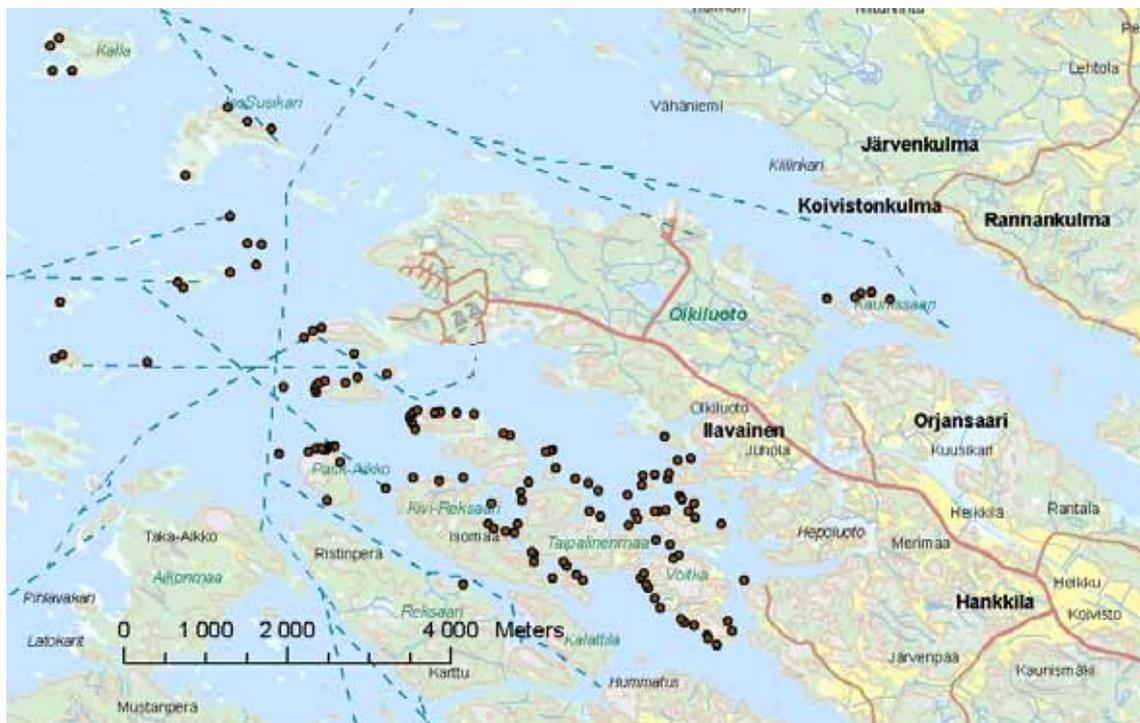
Figure 1. Map of the research area and observation points marked with black squares (Base map © National Land Survey, Licence no 13/MYY/07).

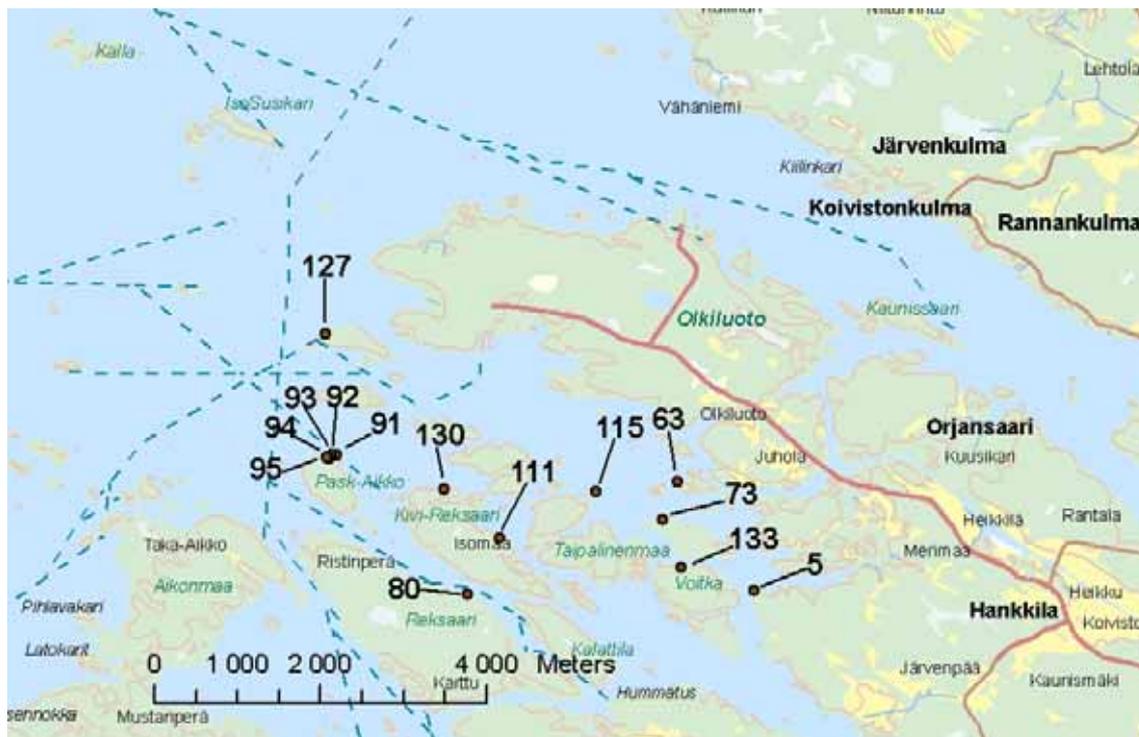
Figure 2. Map of the faults in the surroundings of Olkiluoto. Observation numbers are shown (Base map © National Land Survey, Licence no 13/MYY/07).

During this research a total of 30 faults were detected. This number includes a few mylonites and small fracture zones. They are listed in table 1. For further discussion the group has been divided into two, because of the different nature of faults in rapakivi granite. Faults in the Olkiluoto area are shown in figure 2.

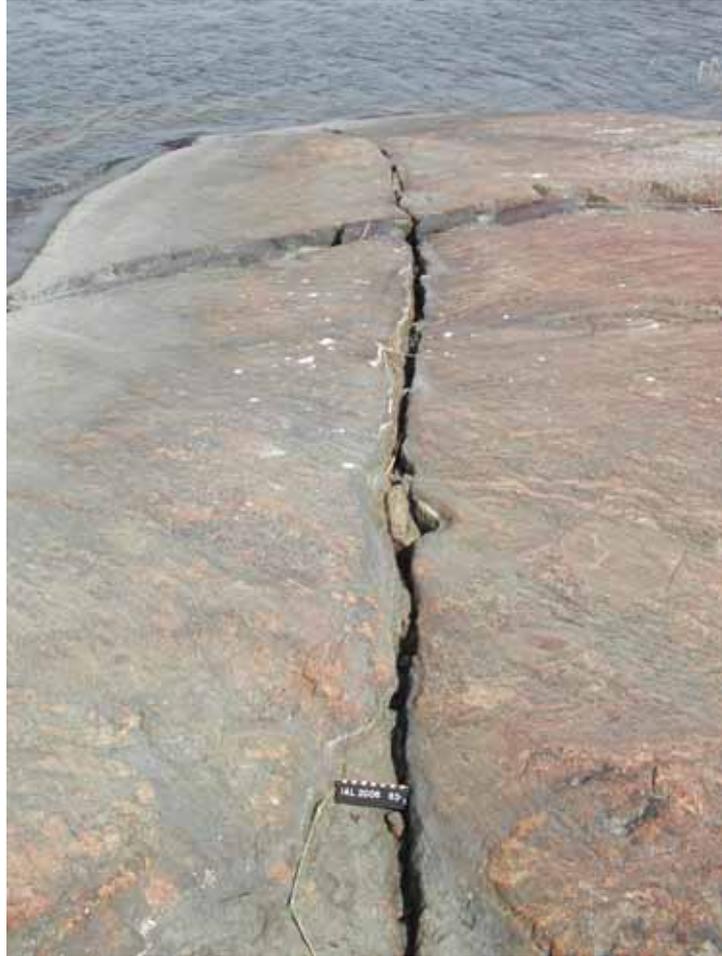
Liaskari (fault 63.1): a ten metre long fracture with an aperture of 10 - 20 mm. The west side of this very undulating fault is 2 – 4 cm higher than the east side (Fig. 3). Between the fault surfaces the rock is mylonitized and eroded. Both ends of the fracture are visible and the height difference decreases to zero at the ends. Only very slight polishing can be found at the edges of the fault. The possibility of a post-glacial component cannot be completely excluded.

Figure 3. A fault on Liaskari island, Eurajoki (IAL-2006- 63.1; $x = 6790.146$; $y = 1526.493$). The height difference is 2 - 4 cm, W-side (left) is higher, strike 158° and ice has come from 297° . The tag is 15 cm long.

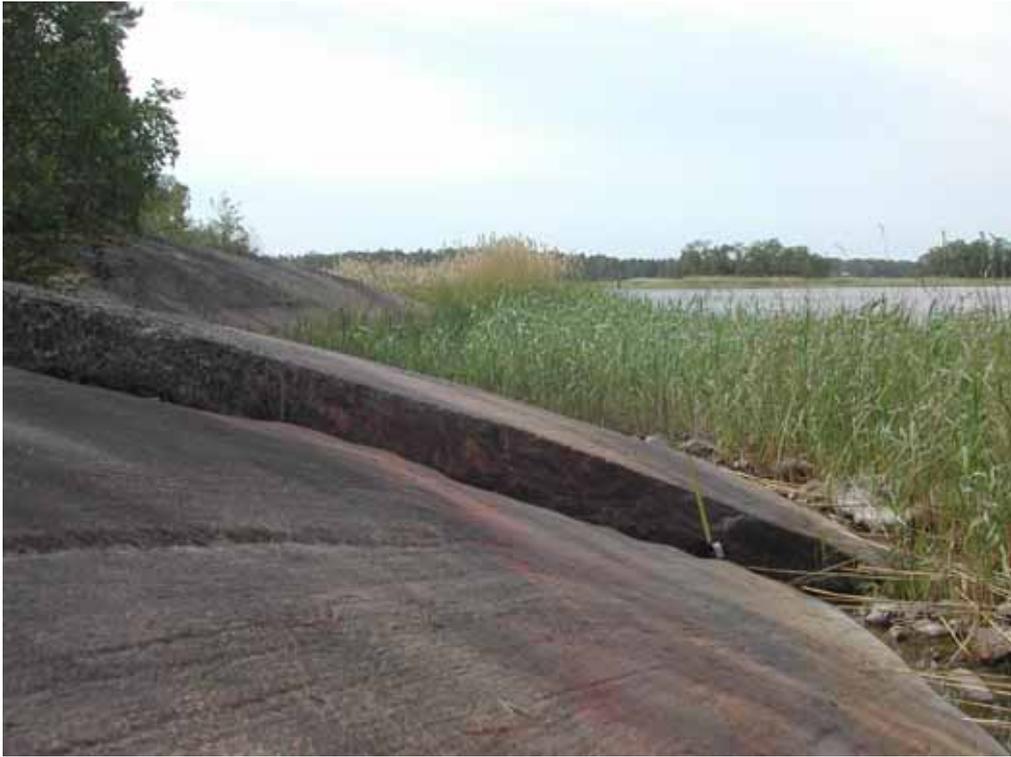
Pukkiluoto (fault 73.1): a quite sharp, 18 cm high scarp, striking 160°. This fault has the character of an old fracture; the aperture is great (80 – 100 mm) and on the bottom there is a fractured, but compact rock. The proximal side (the side of glaciation centre) of the

outcrop (and the fault) is higher, but the rough striations do not continue across the fault (Fig. 4). On the distal side (the side further away from the glaciation centre) the nearest 0.5 – 1 m of rock surface is only slightly polished by ice. The fine striations there also have a different direction to the main ones. Both pieces of evidence prove that the ice has moved over the scarp, not an even surface, and that the surface near the fault on the distal side has not received the whole pressure of flowing ice. So it is possible to conclude that this fault already existed in the glacial period.

Figure 4. A fault on Pukkiluoto island, Rauma (IAL-2006- 73.1; $x = 6789,690$; $y = 1526,314$). Scarp is 18 cm, strike 160° and ice has come from 300° .

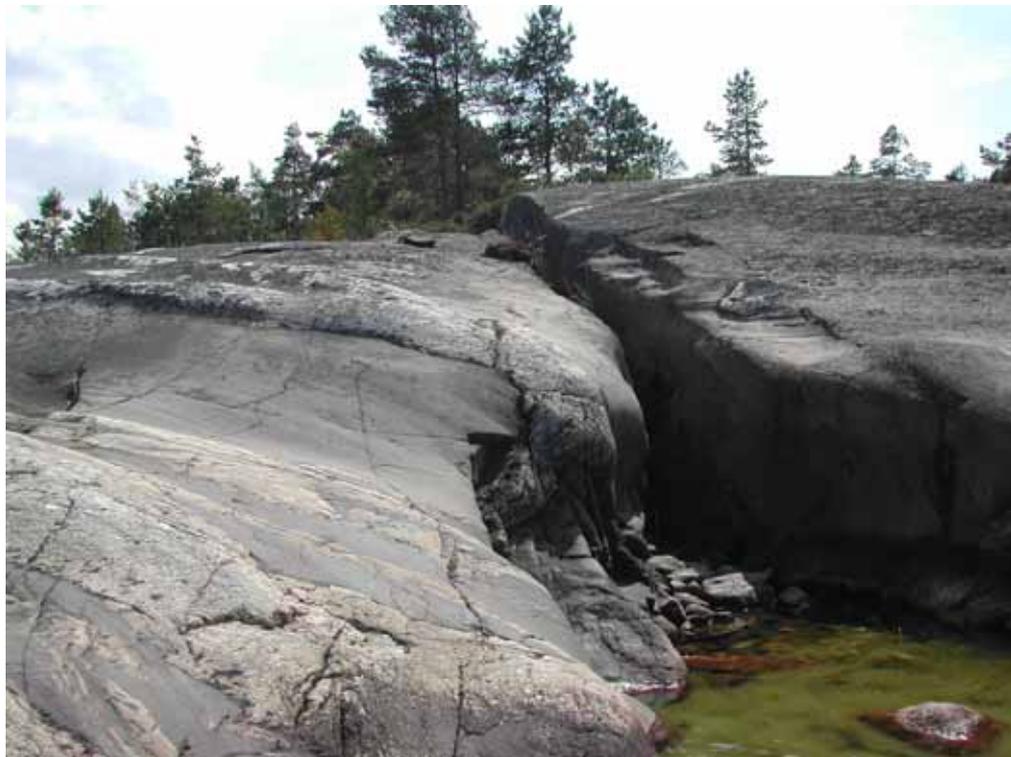
Pask-Aikko (faults 91.1, 92.1, 93.1, 94.1, 94.2, 94.6, 95.1 and 95.4): several faults and fractures with almost uniform strike, 160° – 180° , and near vertical dip. Many faults have also a scarp from 30 to 120 cm high (Figs. 5 and 6) and the sense of movement is ambiguous. Fault 91.1 (Fig. 4) has a high proximal side and a lower distal one. The vertical fault surfaces are also polished by ice. They are 5 – 30 cm apart and between them the rock is very fractured and eroded to the depth of 0.5 – 1.5 metres. It seems clear, that the scarp already existed during glaciation and no signs of later activation are available. In figure 5 the scarp is higher on the distal side and the vertical plane is polished and the upper corner rounded by ice, which are clear indications that also this fault already existed in the glacial period. The other faults on the north shore of Pask-Aikko have similar features to those described.

Figure 5. A fault on Pask-Aikko island (IAL-2006- 91.1; $x = 6790,482$; $y = 1522,390$). Ice movement from right (290°) to left.

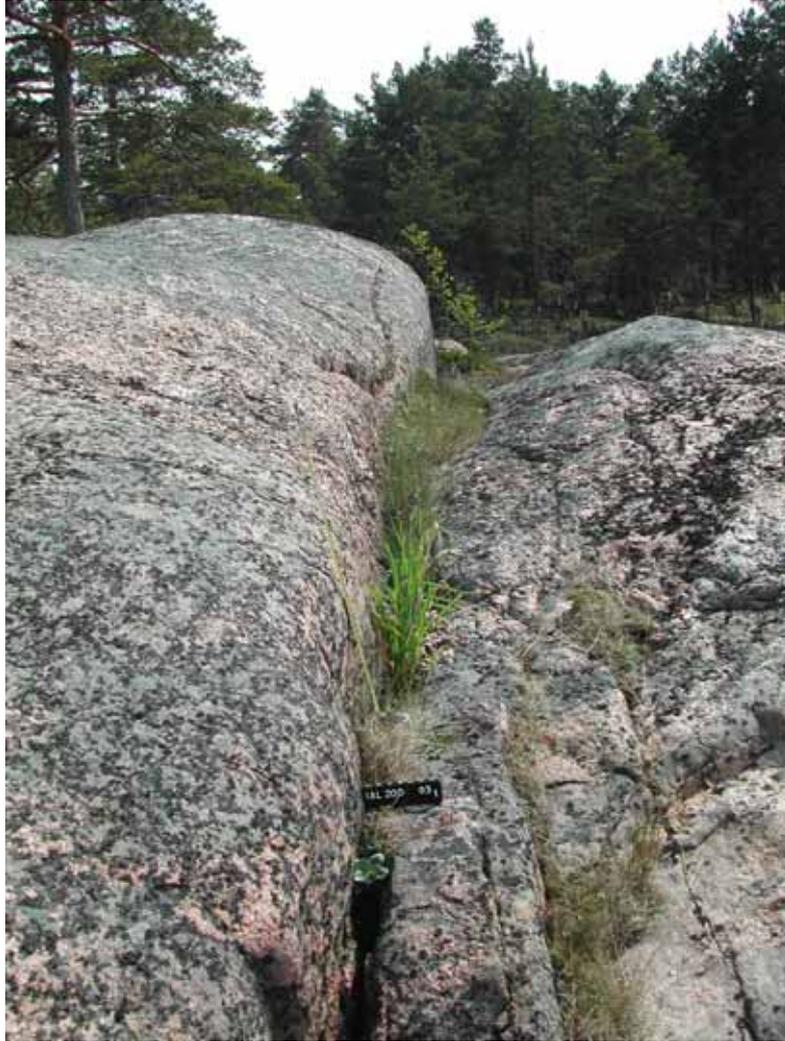
Figure 6. A fault on Pask-Aikko island (IAL-2006-93.1; $x = 6790,437$; $y = 1522,293$). The scarp height varies 30 – 110 cm. The tag is 15 cm long.

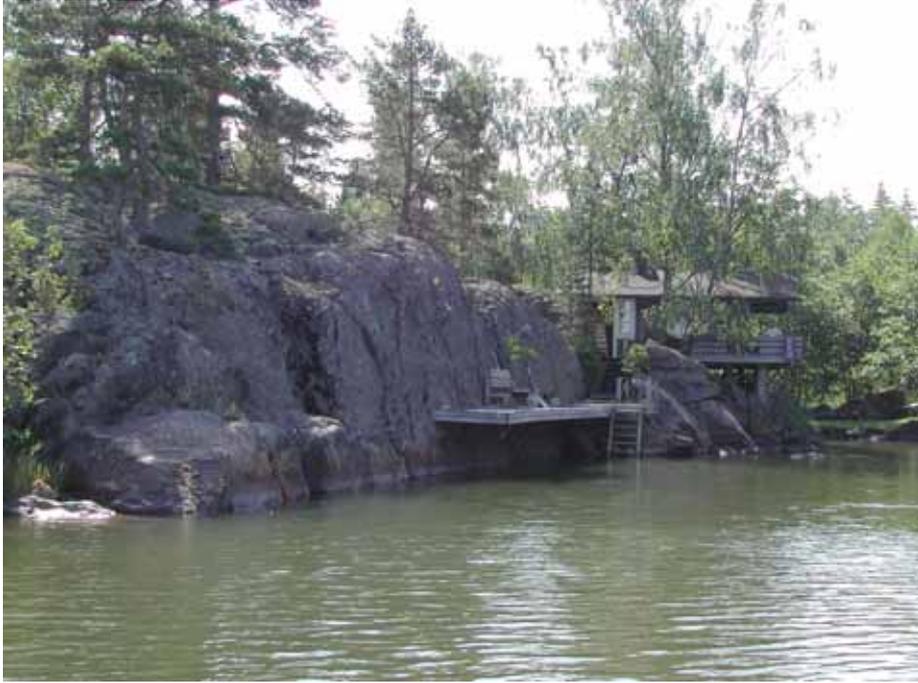
Kivi-Reksaari (fault 111.1 and shear zone 130.1): here is the highest scarp of the whole research area and it is approximately 3 – 6 m high with a length of 22 m (Fig. 7). About 1.5 – 2 m of this scarp is below sea level. There is no indication of post-glacial reactivation. The scarp itself is slightly polished by ice. At least a 35 m long, old shear zone (130.1), about 1 – 2 metres in breadth follows the north shore of the island Kivi-Reksaari. The rock is mostly highly fractured and in places mylonitized. The form of the bedrock surface shows that it has been ground to smoothness by ice, so any later movement is improbable.

Figure 7. About 1.5 – 2 m of this scarp is below sea level. The whole height is approximately 3 – 6 m. Kivi-Reksaari, Rauma (IAL-2006-111.1; $x = 6789,471$; $y = 1524,347$). Strike 360° .

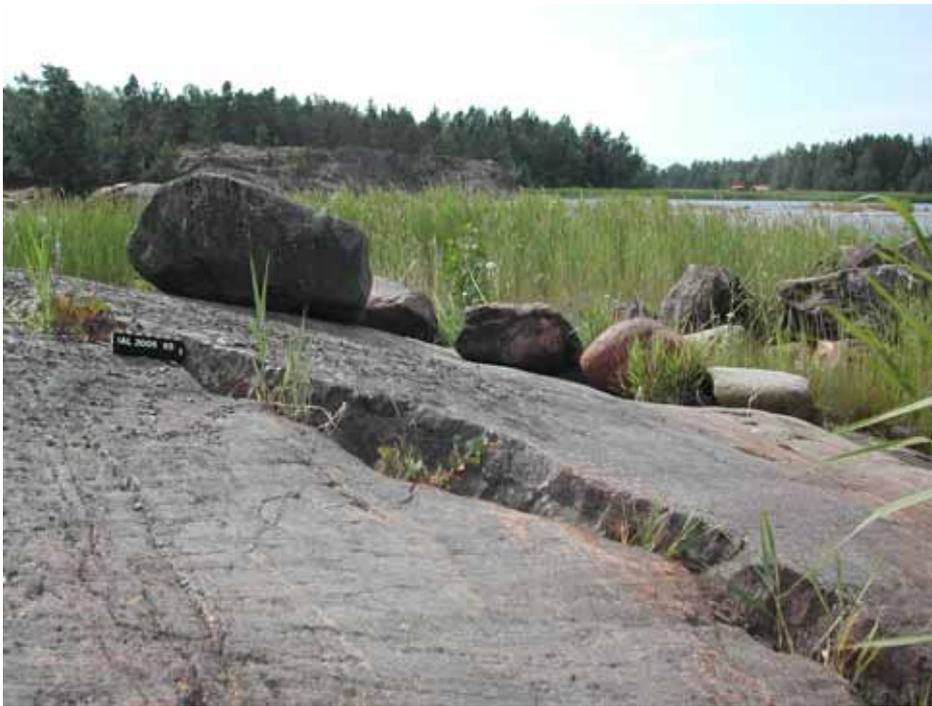
Tormkari (fault 115.1): this small islet has 12 m long fault (Fig. 8). The proximal side is the higher one and the maximal vertical height difference at the northern end is 17 cm. This height difference decreases to zero at the southern end, just before the fault disappears under the soil cover. Horizontal displacement cannot be proved because of the lichen covering the rock. Striations are weak on both sides. The edge of fault is slightly polished, which is not enough to prove a glacial or pre-glacial nature. This one is not possible to determine whether it is pre-glacial or post-glacial fault. Similar to the Liaskari fault (63.1).

Figure 8. The outcrop and fault on Tormkari islet, Rauma. (IAL-2006-115.1; $x = 6790,036$; $y = 1525,500$, strike 170°).

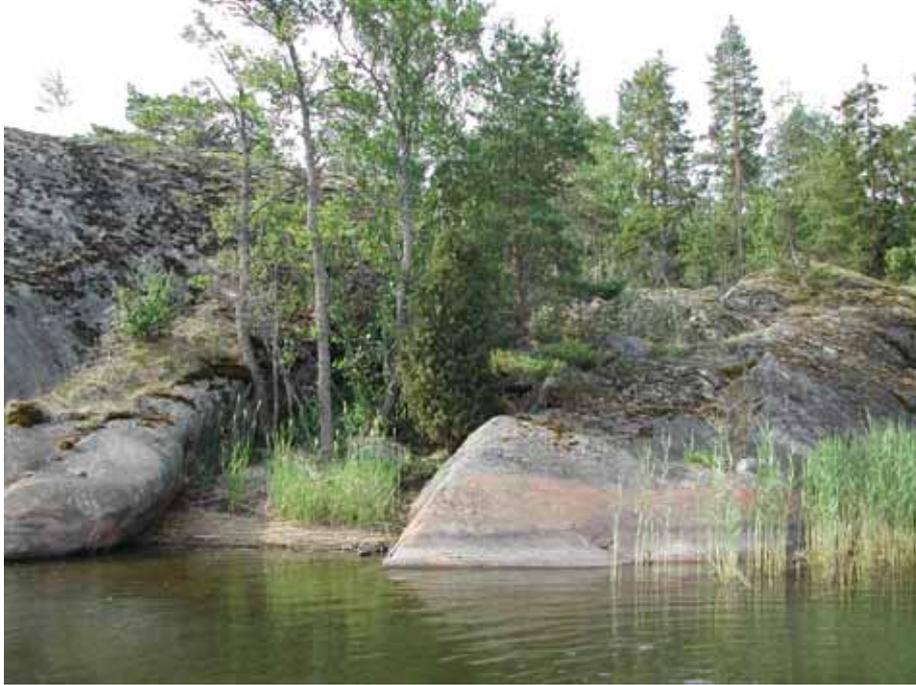
Voitka (fault 133.1): a 25 m long, old fault and fracture zone with ice-polished surfaces and quite deeply eroded fractured rock between the fault surfaces (Fig. 9) near the

shore, but further off, on the bedrock top, the aperture is only 5 cm. This fault is very similar to number 5.1 (Manterempää) and also the strikes are near each other (05 – 19 degrees). They are old pre-glacial faults without any signs of post-glacial reactivation.

Figure 9. *The fault on the north shore of Voitka island, Rauma. (IAL-2006-133.1; $x = 6789.104$; $y = 1526.538$, strike 170°).*

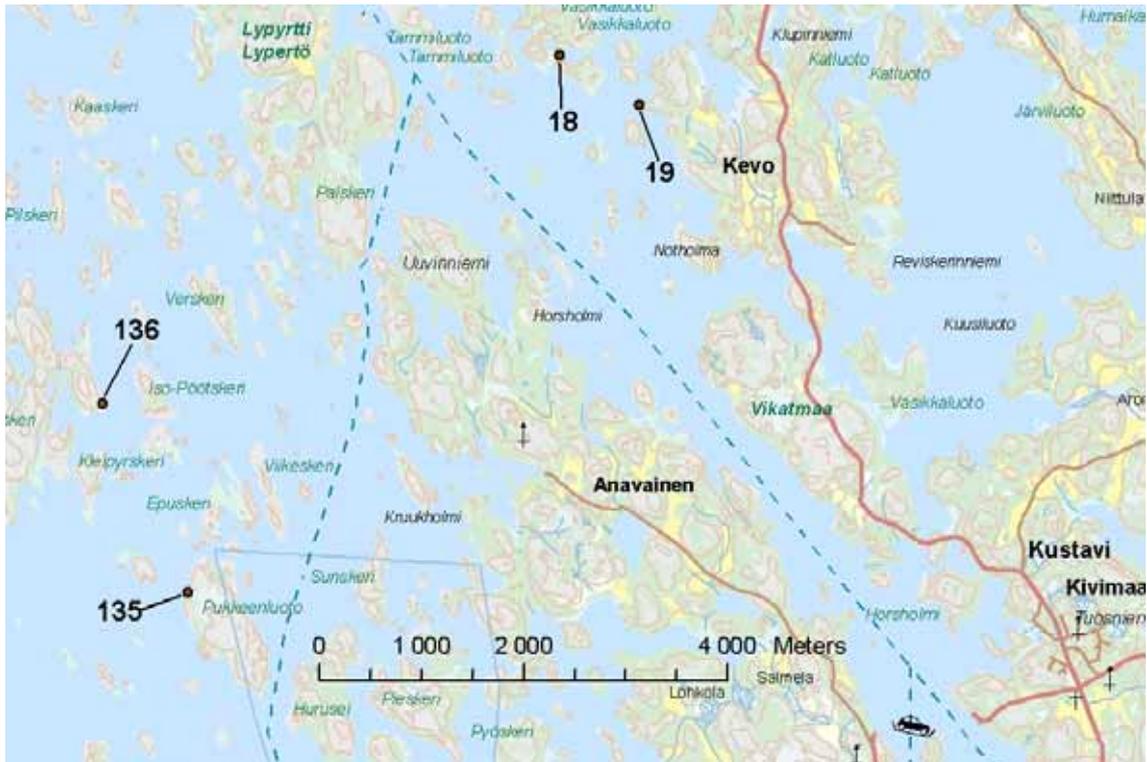
Figure 10. Map of the studied faults in Kustavi. Observation numbers are shown (Base map © National Land Survey, Licence no 13/MYY/07).

The reported postglacial faults of Kustavi are situated in the rapakivi area, while Raippaluoto lies within a completely different metamorphic area with mica gneisses and inhomogeneous infracrustal rocks. Also the jointing is quite different, where rapakivi is characterised by three clear joint directions, one of which is nearly horizontal. The studied faults from Kustavi are shown in figure 10.

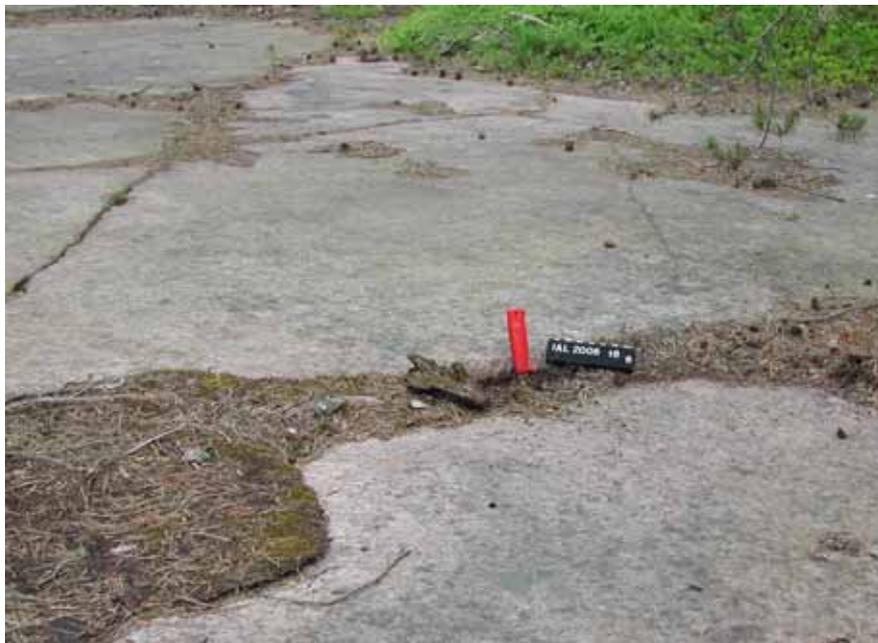
Observation point Vasikkaluoto (Faults 18.1 – 18.6) is a flat outcrop (about 40 x 30 sq. m) where there are several quite rough fractures (undulation 5 – 6 cm, which is more than in typical rapakivi outcrops). On closer inspection, it can be seen that the fractures are filled with loose soil and have an aperture from 3 to 40 mm (Fig. 12) and the different blocks have a few millimetre or centimetre step (height difference). On this wide outcrop all the steps are lower in the direction of ice movement. It seems possible that the ice sheet has pushed the blocks along a near-horizontal plane and, at the same time, apart from each other. In the immediate terrain there are examples of near-horizontal fractures and great (e.g. 3 x 4 x 5 m) blocks, which have moved along them. The same kind of small structure was found on the shore of Sammalperänniemi (Fault 19.1, Fig. 13). There is only one fault and its strike differs by just 10° from the striations. These kinds of faults are glacial, not postglacial. They have no relation to the post-glacial land uplift.

Figure 12. A vertical fault with aperture 20 mm has been caused by the ice sheet pushing the blocks of bedrock. Vasikkaluoto, Kustavi (IAL-2006-18.6; $x = 6721,231$; $y = 1514,603$).

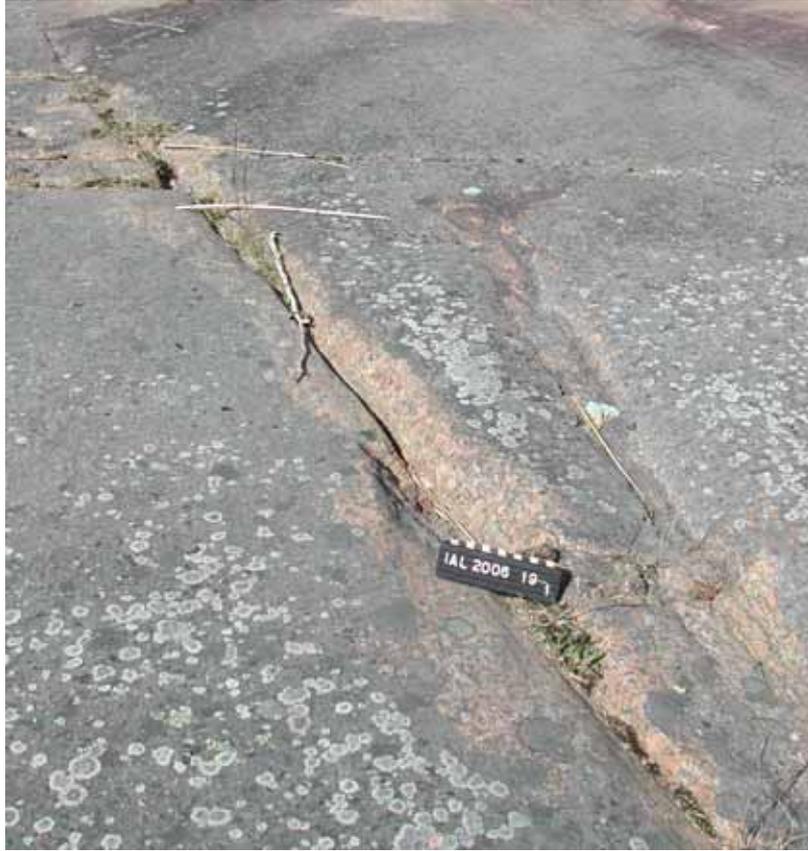
Figure 13. Vertical displacement is a result of horizontal (dextral) movement. Relatively thin blocks have been pushed along an inclined (near-horizontal) fracture surface by the ice sheet. Sammalperänniemi, Kustavi (IAL-2006-19.1; $x = 6720,737$; $y = 1515,374$).

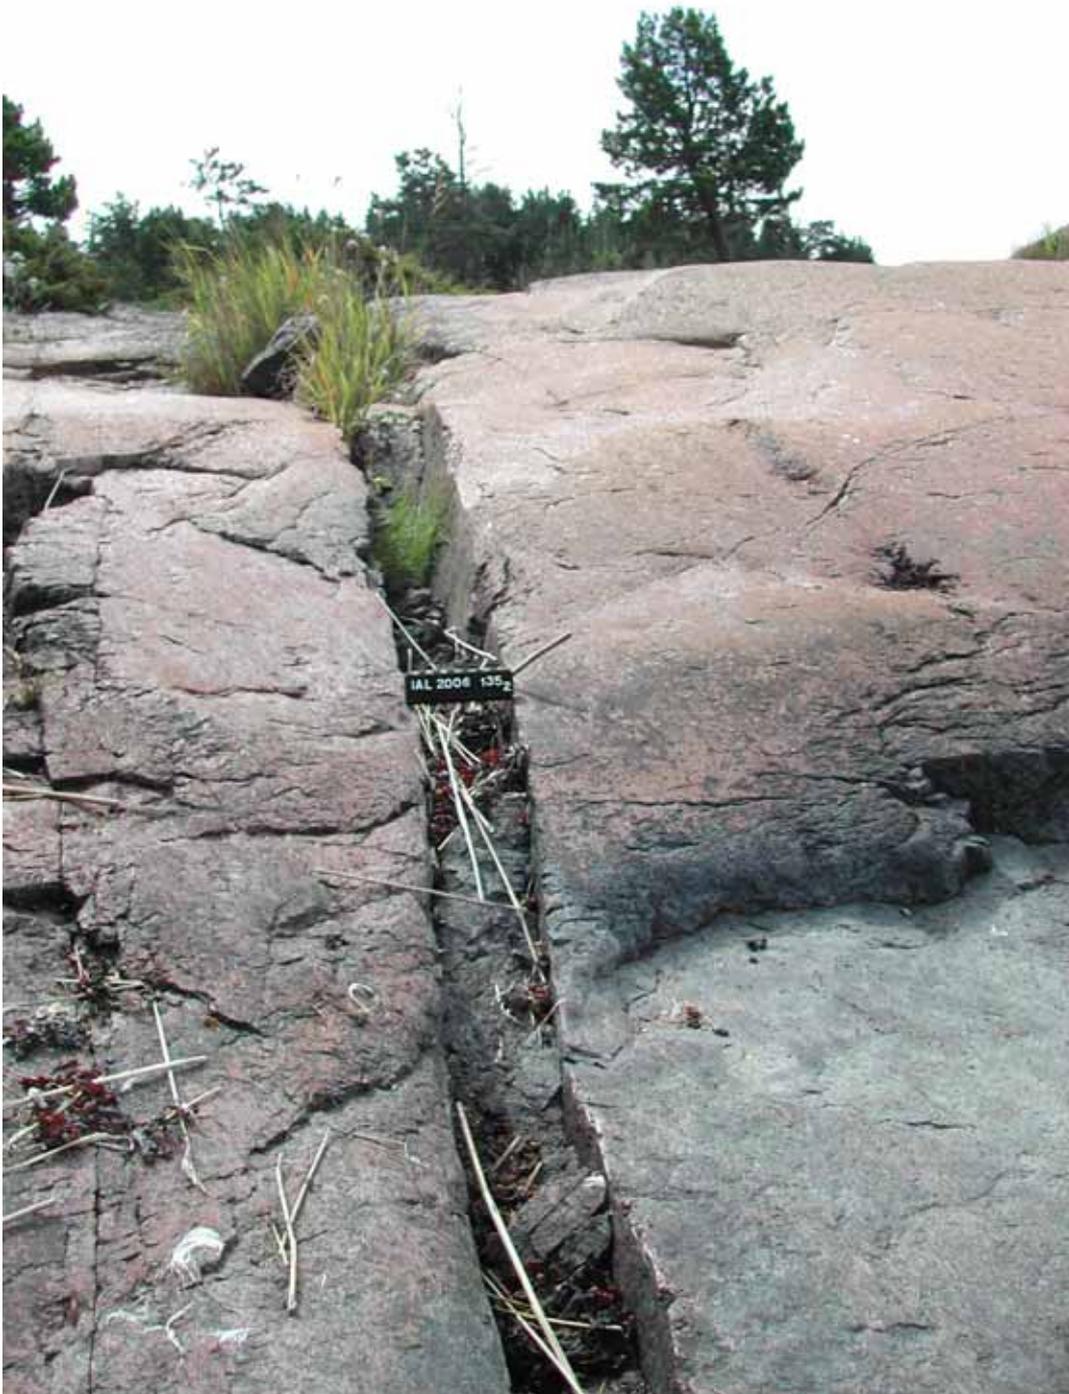
Postglacial faults in Pukkeenuoto (135.1 and 135.2) and Lanskeri (136.1 – 136.4) have been reported by Kujansuu (in Kuivamäki et al. 1998). On the NW shore of Pukkeenuoto island there is a 55 m long sharp fault (Fig. 14) and several fractures, mylonites and even scarps striking almost parallel ($150^\circ - 160^\circ$), which differs only slightly from the regional, very strong lineaments (ca. $140^\circ - 150^\circ$). The main fault is composed of two fractures, which are 15 cm apart and contain very fractured rock between them. The fracture surfaces, as well as the edges are sharp and do not contain any striations or polishing caused by ice.

Figure 14. The most spectacular part of the fault on Pukkeenuoto island, Kustavi (IAL-2006-135.2; $x = 6715,924$; $y = 1510,956$).

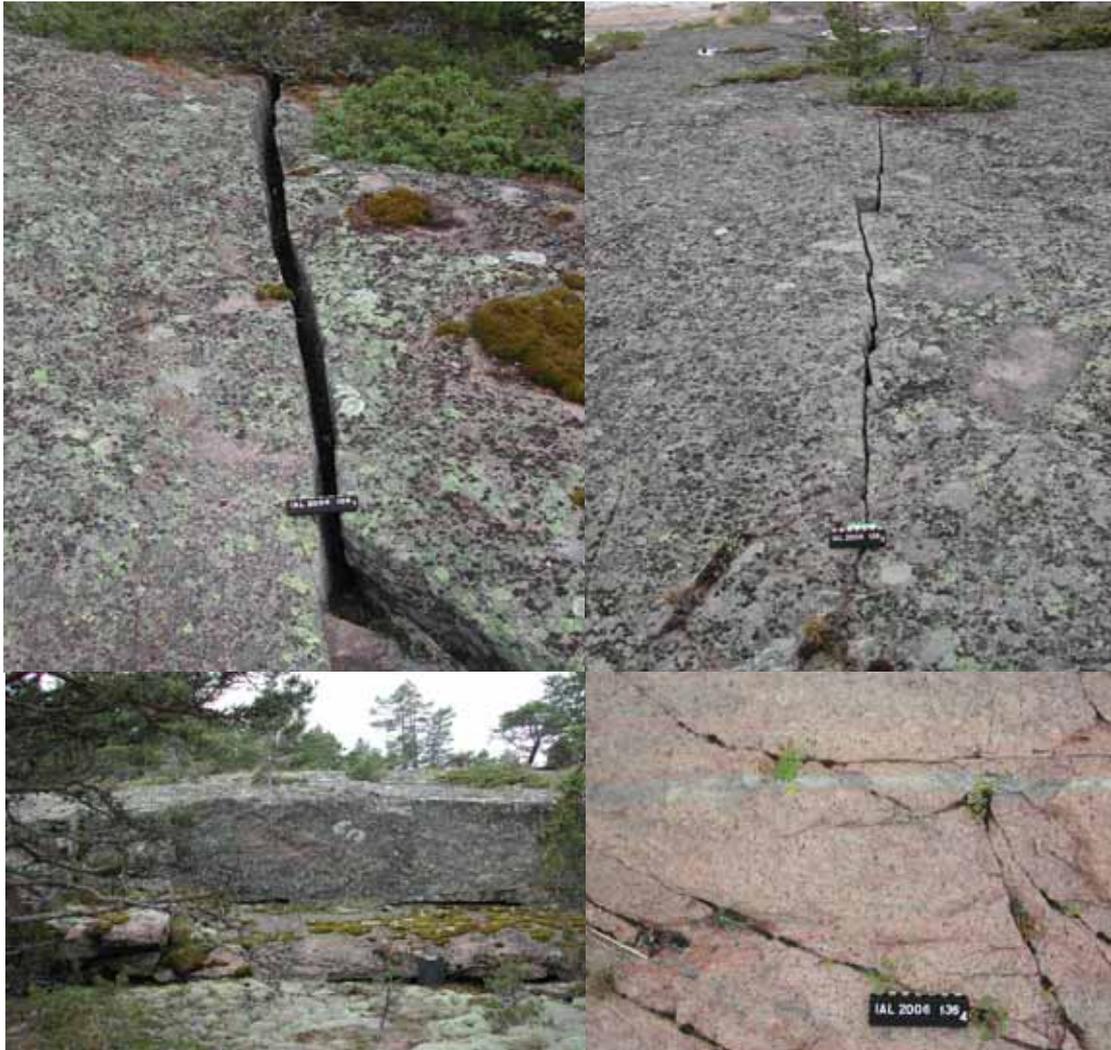
On the island of Lanskeri two faults (136.1 and 136.2), one open fracture/fault (163.3) and one mylonite (136.4) have been mapped. From these only the quartz-filled mylonite (136.4 in Fig. 15) have the same strike (157°) as the fault described from Pukkeenuoto. The others strike almost N – S. One of them is a typical large block, which has slipped along the first horizontal fracture at a depth of 1.0 – 1.2 metres (Fig. 15). Just this and the open fracture 136.3 have the same strike as the fault, which was sketched on a map by Kujansuu (Kuivamäki et al. 1998). It is possible that, for example, with aerial photo interpretation this kind of fractures may give the impression of a postglacial fault. The fourth fault (136.2) from Lanskeri is located onshore and is a typical dextral fault without any evidence of its age.

Figure 15. *Faults of Lanskeri. IAL-2006-136.1 (top left), IAL-2006-136.3 (top right) and the explanation to them: horizontal open fracture (down left). Quartz-filled mylonite (IAL-2006-136.4, down right. $x = 6717.786$; $y = 1510.111$).*

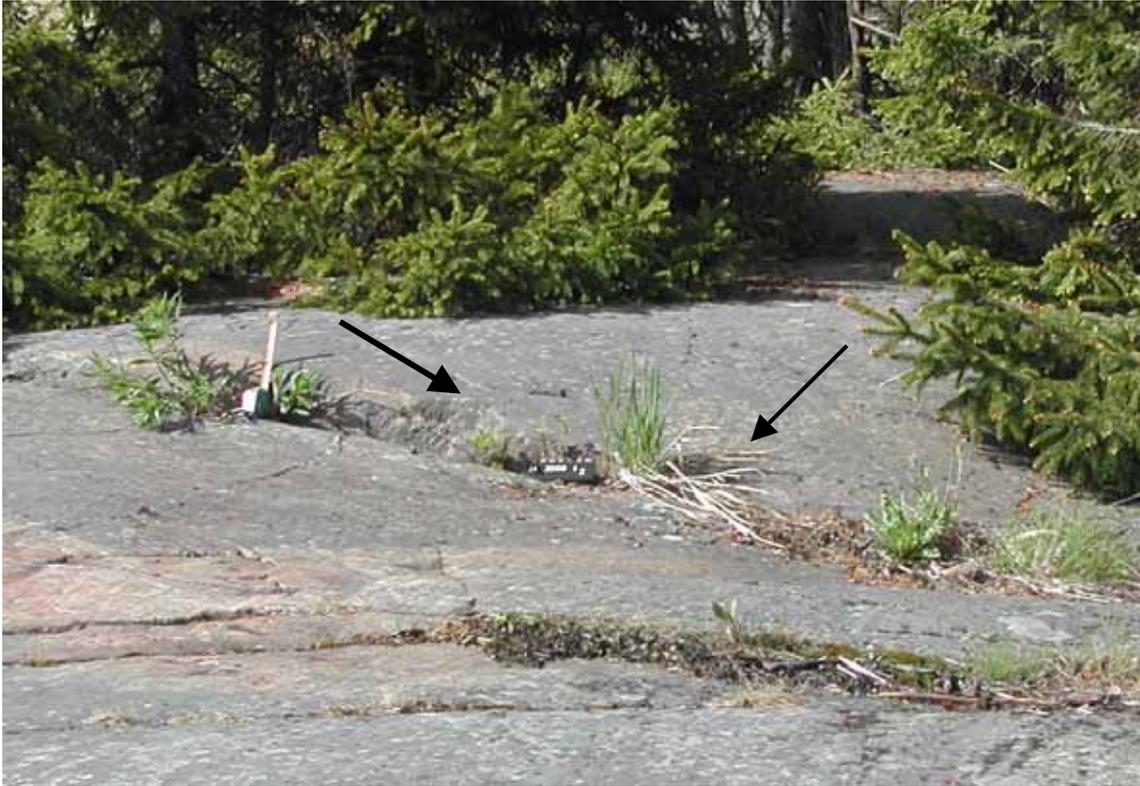
The glacial striations on this outcrop are from several directions and mostly quite weak and it is not easy to say whether they continue across the observed fracture. The main direction of striations is 333° and the strike of the fracture 073° . The proximal side of the fracture is the higher one with a maximum height difference of 12 cm. The vertical surface of the fracture is also slightly smooth-worn or polished (Fig. 16). Therefore it is not considered a post-glacial fault.

Figure 16. *The fault of Raippaluoto (2006-IAL-1.2; $x = 7011,011$; $y = 1521,447$). Two directions of striations are marked, the main direction with a thicker arrow. Note that in the right margin of photo the vertical displacement is zero.*

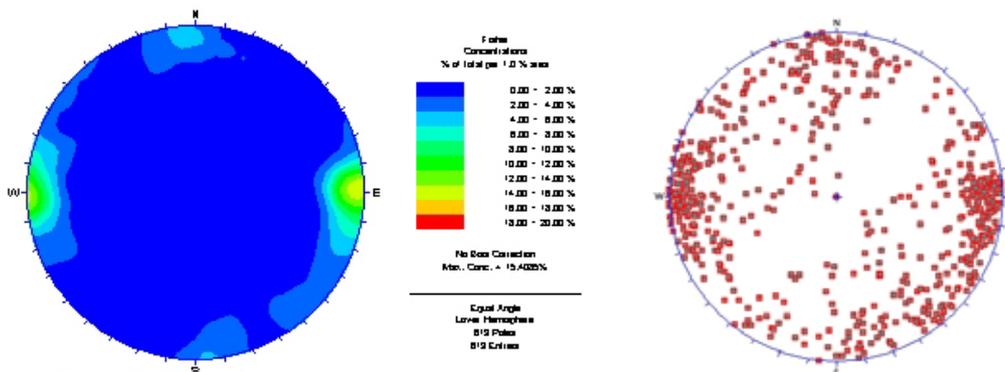
Results of all fractures (Fig. 17) show that most of them are near-vertical and very often striking N – S. When fractures longer than 10 metres are selected, this phenomena is still stronger (Fig. 18). Faults around Olkiluoto also belong to this group (Fig. 19a), but faults from the Kustavi rapakivi area are mostly WSW – ENE striking (Fig. 19b). In both cases the number of observations is small.

Figure 17. Orientation of all fractures (dip/dip direction, $n = 619$).

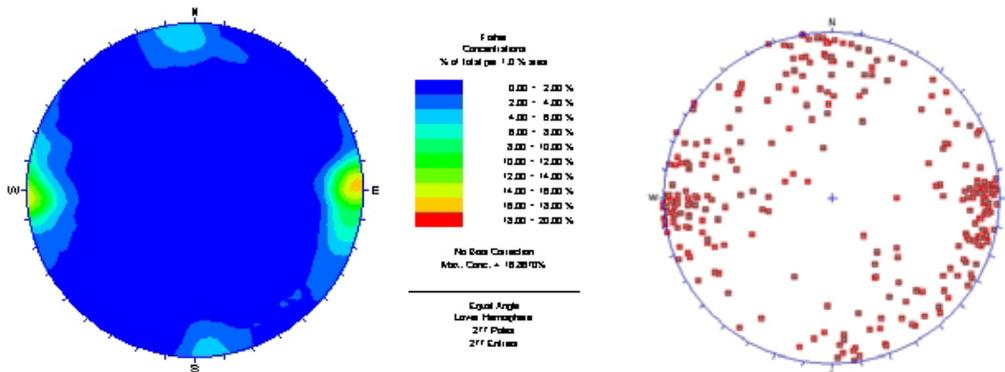
Figure 18. Orientation of fractures over 10 m in length ($n = 277$).

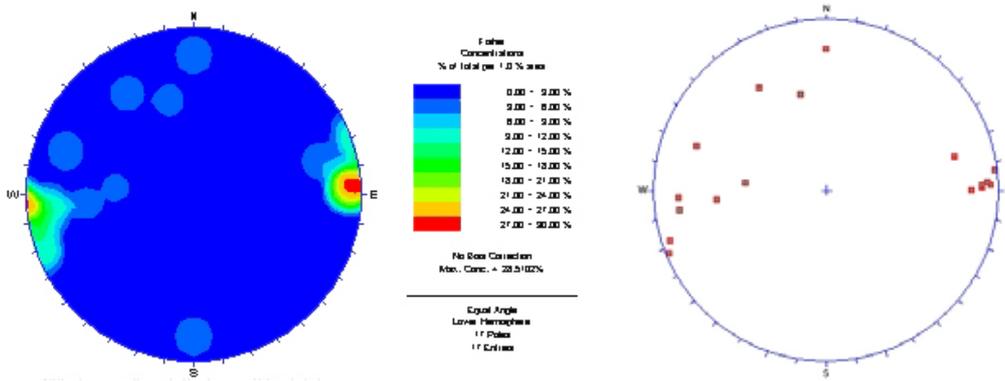
Figure 19a. Orientation of faults around Olkiluoto Island (n = 17)

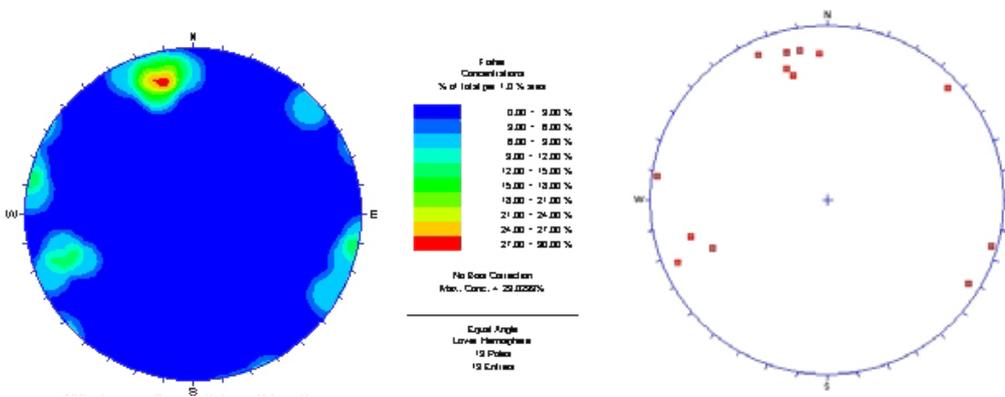
Figure 19b. Orientation of faults in rapakivi area in Kustavi (n = 13).

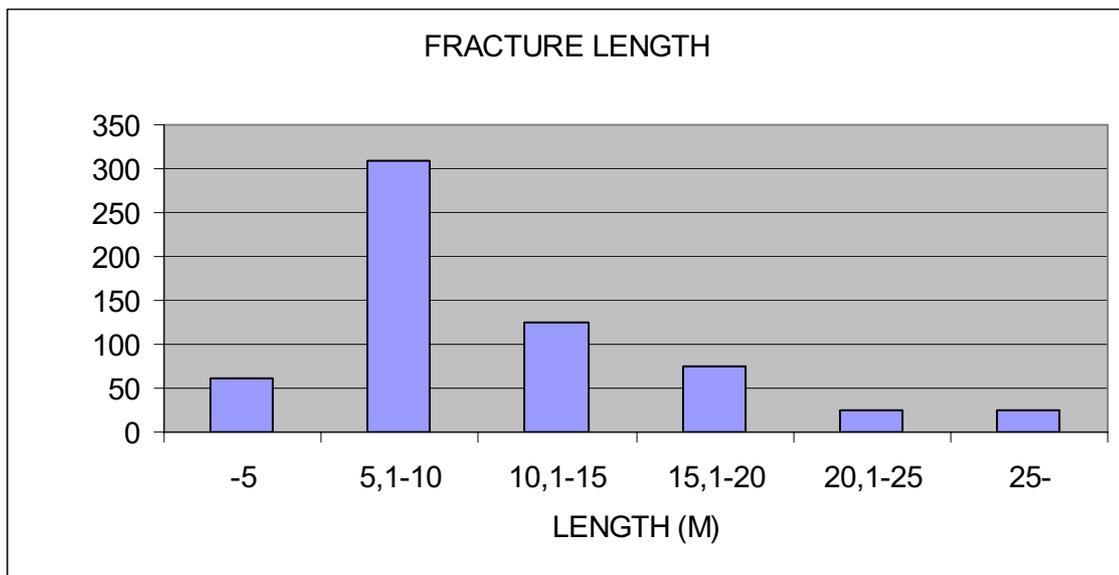
The fracture length distribution is shown in Figure 20. Fractures shorter than 4 metres were not included in this study. Soil cover often limited the visible length of the fractures or the end of a fracture disappeared beneath the water. Both ends were shown in 47 % of the fractures.

Figure 20. Fracture length distribution (n = 617).
