DOPAS

Deliverable no. 4.6

Monitoring data from the EPSP plug test summary report

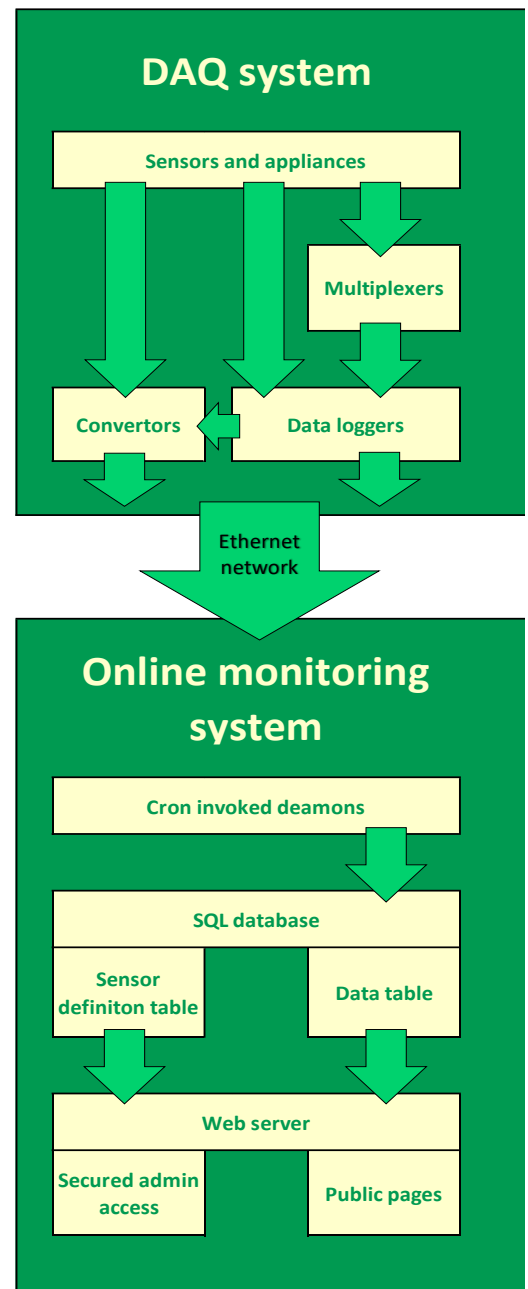
Figure 3 - EPSP measurement system

The system has two main elements: the data acquisition system (DAQ) and the online monitoring system (Figure 3). The DAQ makes up the main hardware element and is responsible for the actual taking of measurements. The online monitoring system is responsible for data collection, storage and presentation to end-users.

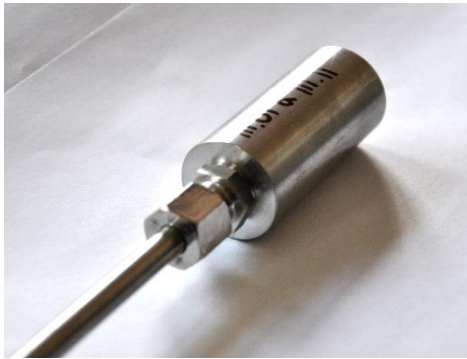
Figure 4 - temperature sensor in a protective housing

The preparation of the sensors was carried out in the workshop of the Josef URC facility and, following assembly, were equipped with protective stainless steel tubing (Figure 4 and Figure 5). The complete assemblies were then transferred to the underground complex once the plug had been constructed. The sensors were either installed in their final positions underground or

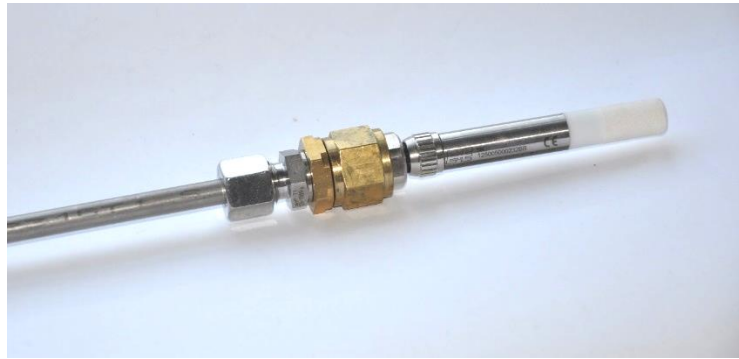
Figure 5 - RH sensor including cabling protection

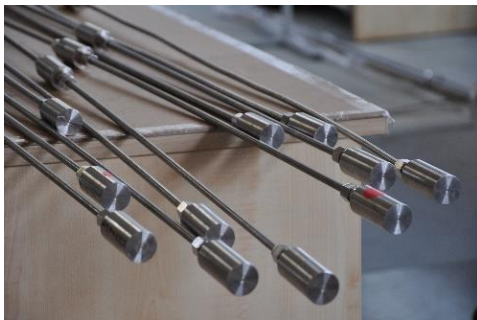
Figure 6 - Sensors ready to be fixed into the assembly

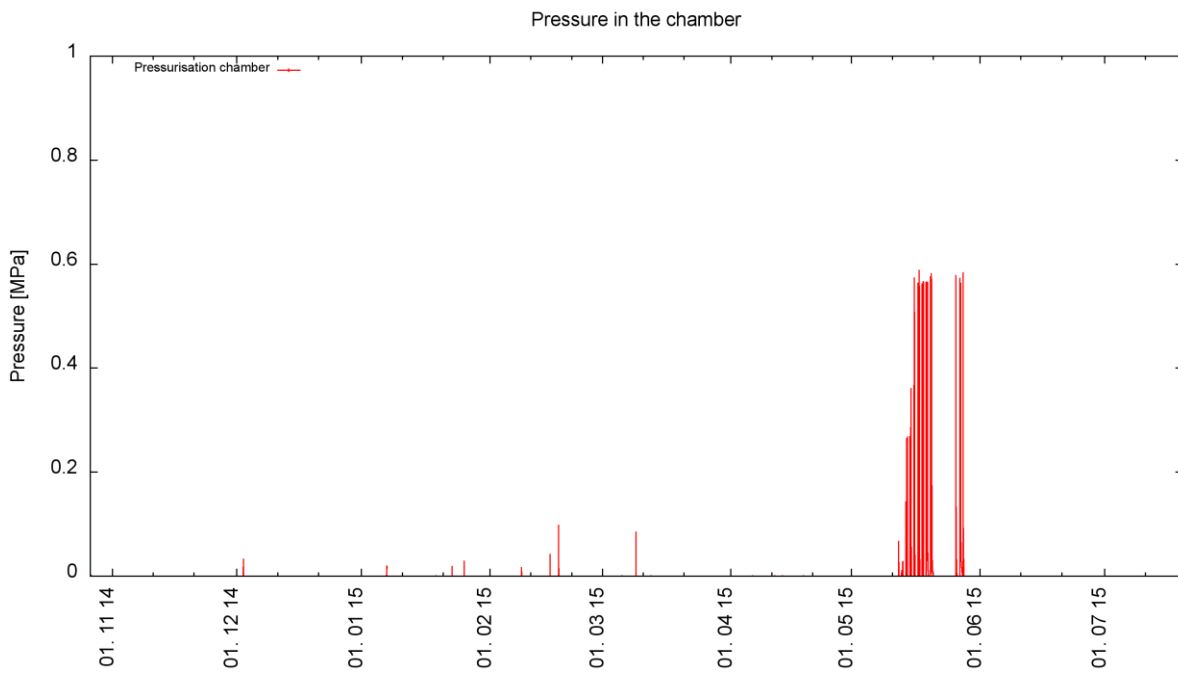
Figure 8 - Water tightness tests (pressure in the chamber)

Table 3 - Leakage tests of the inner plug (injection into the chamber)

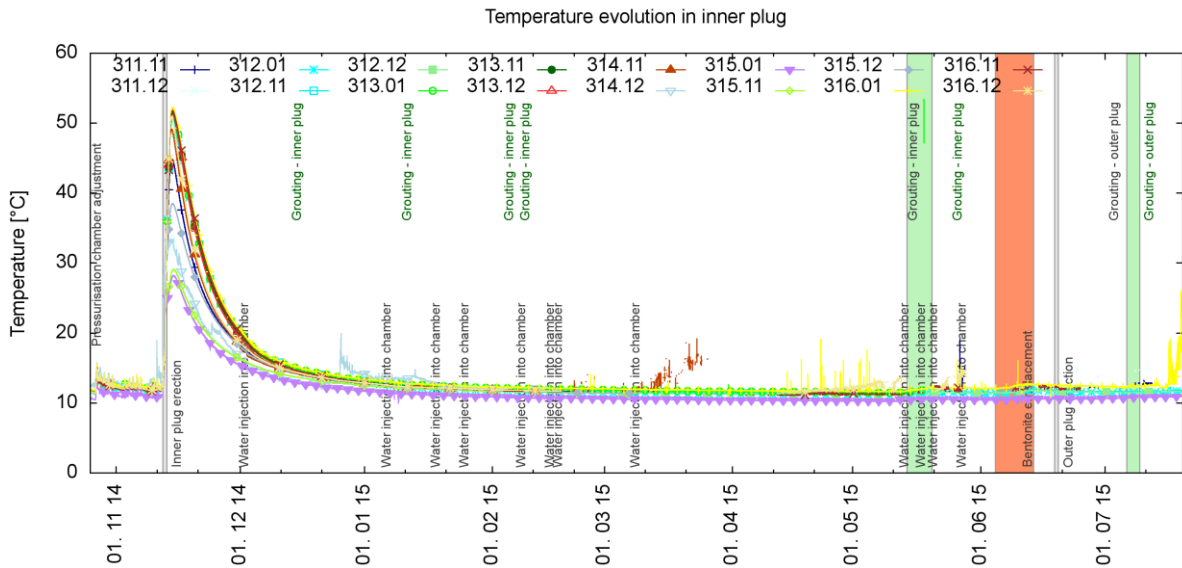
Shrinkage in the range of 2200 - 3600 $\mu\text{m}/\text{m}$ was observed (the initial peak was due to installation). The evolution of strain closely followed the cooling of the plug.

It can be seen that the water tightness tests (pressurisation from the chamber) and contact grouting had a significant impact.

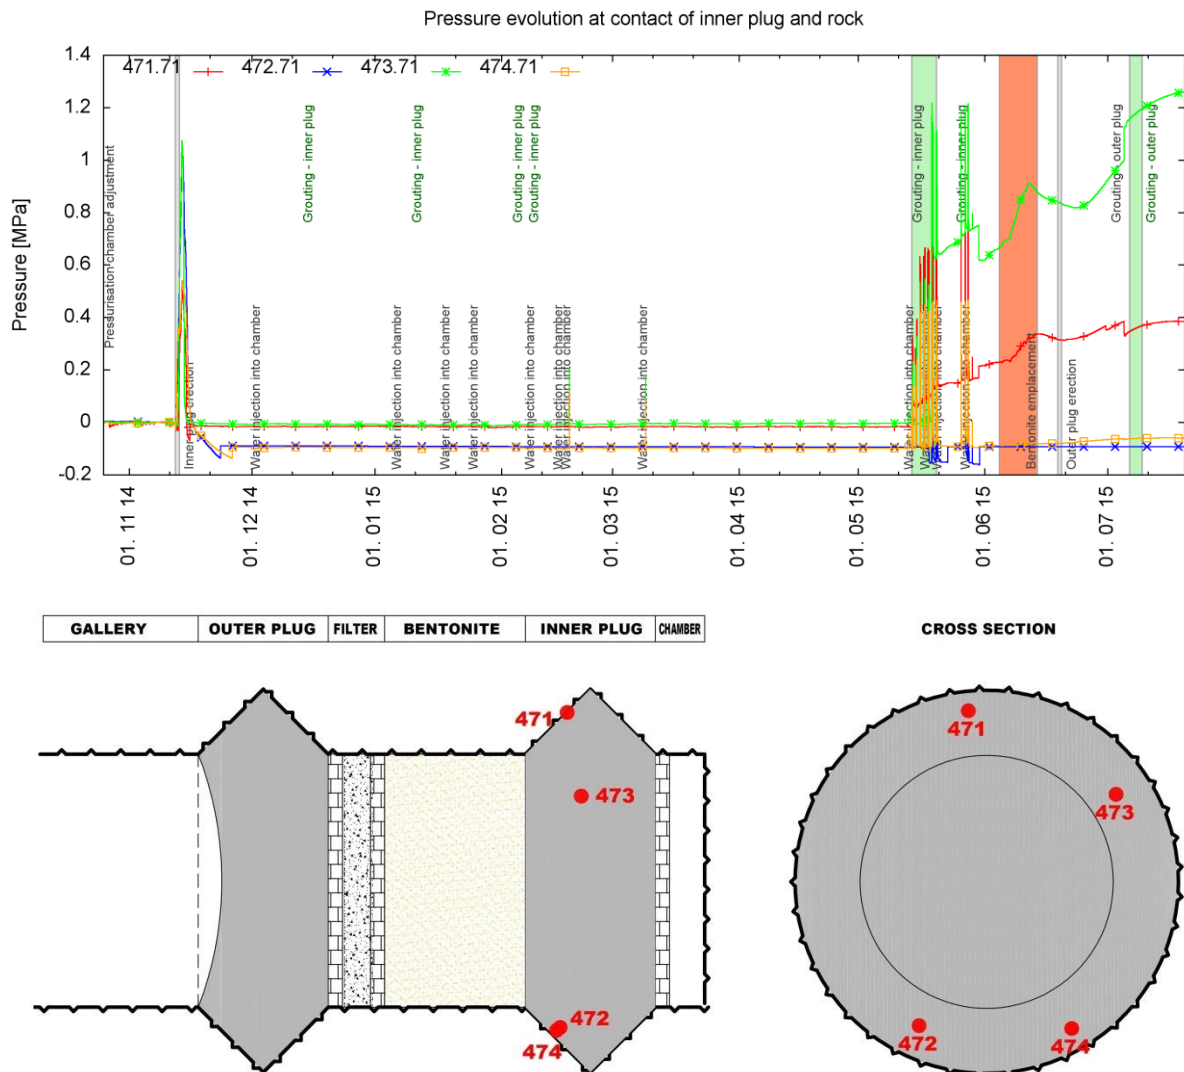
The highest peak was observed 17 hours following shotcreting – half-way before reaching the hydration heat temperature peak. The bottom sensors (472 and 474) measured negative values at certain points which was most probably due to the pulling of the cells by the shrinking body of the concrete plug. The abrupt return towards a zero value points to the cells having separated from the plug or the rock.

The substantial increase reported by the upper cells in May indicates that grouting was successful in the upper parts (i.e. it penetrated into the area monitored by the cell).

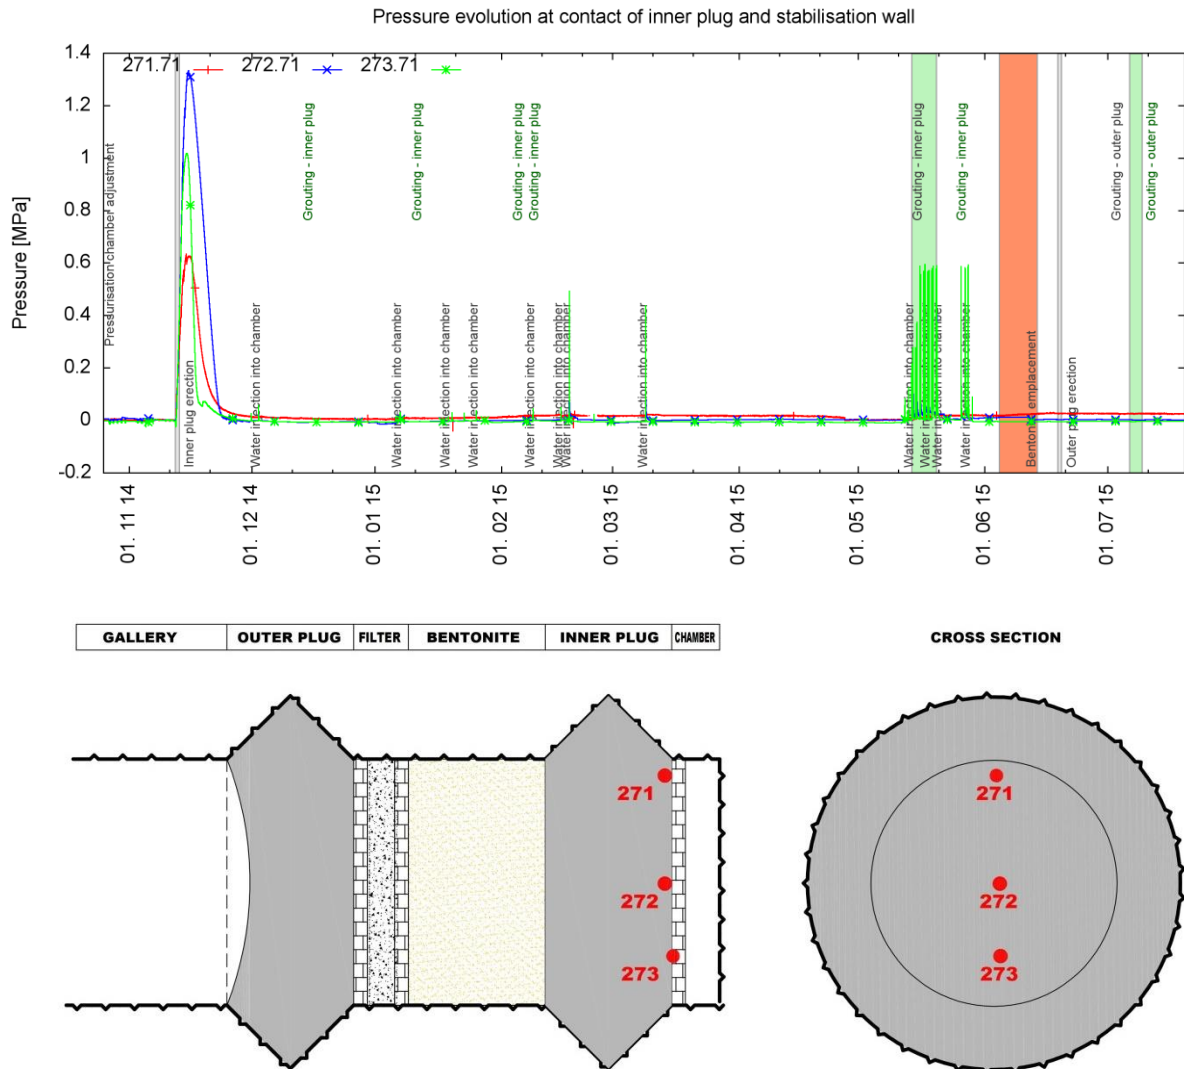
A maximum peak of 1.3MPa was observed 49 hours following shotcreting. The sensors responded according to the behaviour of the shotcrete – expansion, shrinkage and reaction to water injection into the chamber. The response however was “slower” than that of the cells in contact with the rock mass.

The unchanged value following grouting indicates that there was no leakage of the grout behind the plug. The changes observed during grouting were due to water back pressure – indicating that the separation wall does not obstruct water flow and therefore functions as intended.

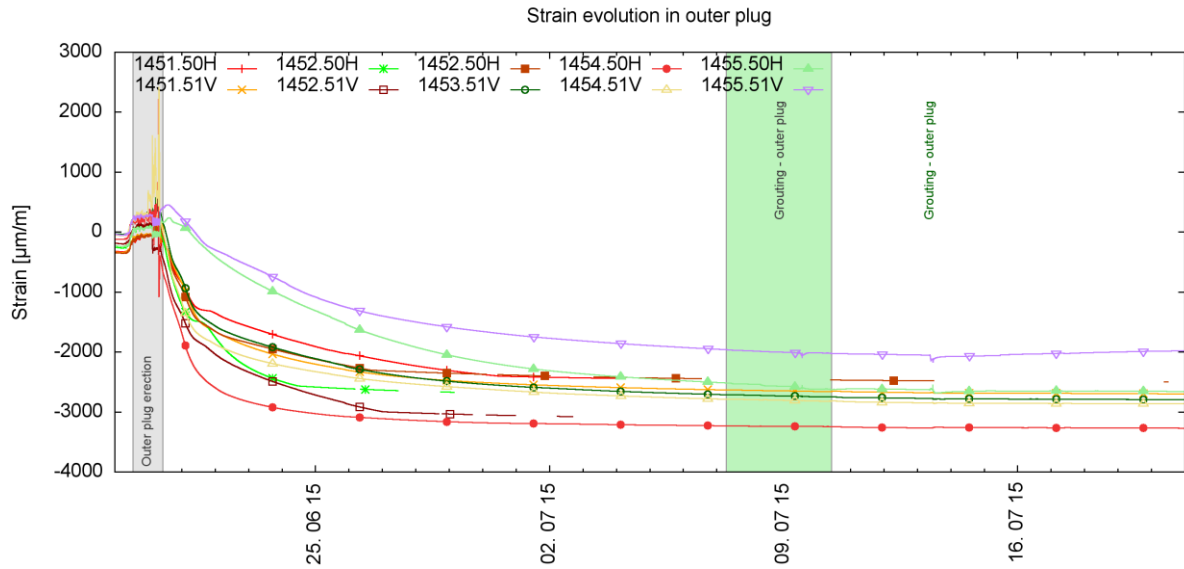
Shrinkage in the range of 2200 - 4000 $\mu\text{m}/\text{m}$ was observed (the initial peak was due to installation) closely following the cooling of the plug.

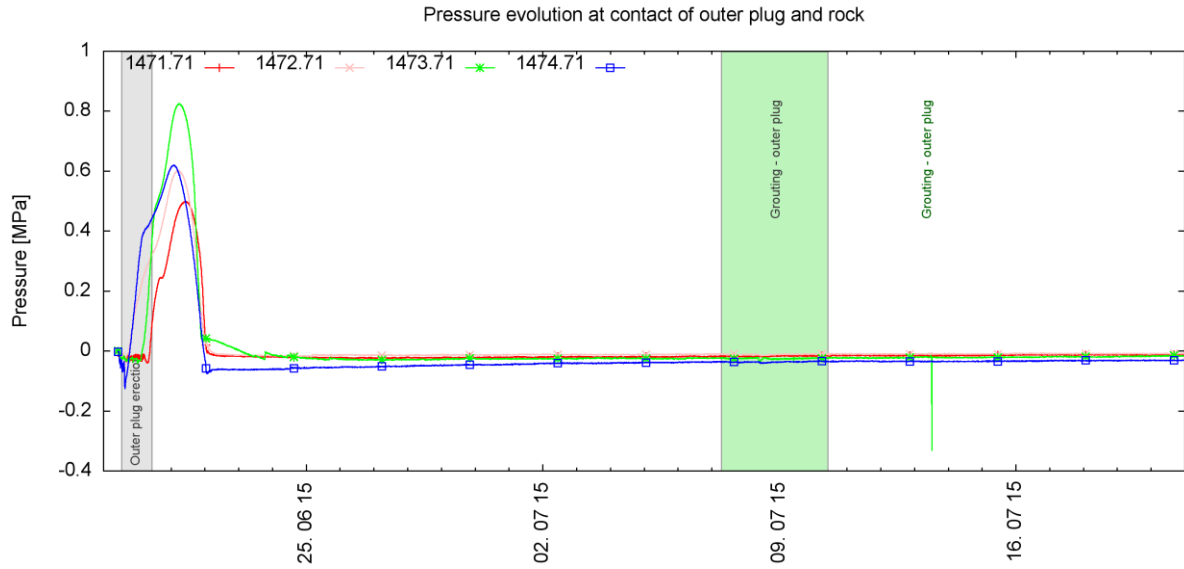
A maximum peak of 0.8MPa was observed 18 hours following shotcreting. The sensors responded according to the behaviour of the shotcrete – expansion, shrinkage and reaction to grouting.

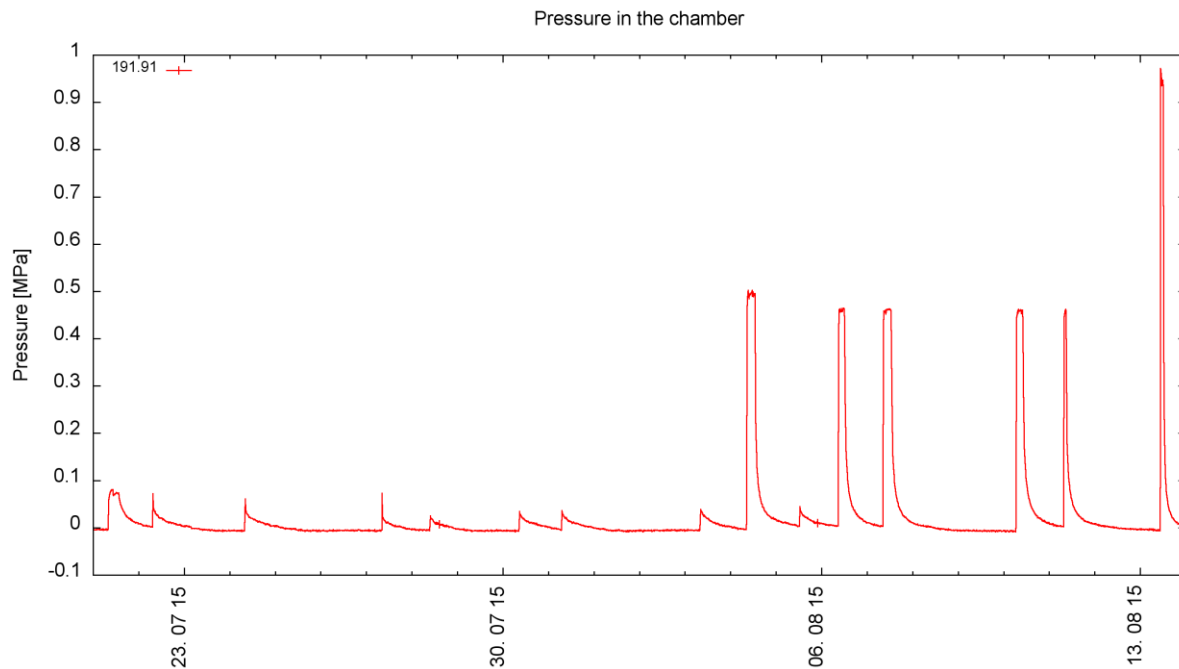
Figure 9 – Pressure in the pressurisation chamber during Phase 1

The graph below shows the evolution of pressure in the chamber (pressure sensor 191 – situated in the upper part of the chamber).
