**Working Report 2016-52**

# **Parametrisation of Fractures — PUSH Test Execution and Back-Analysis**

**October 2016**

**POSIVA OY**

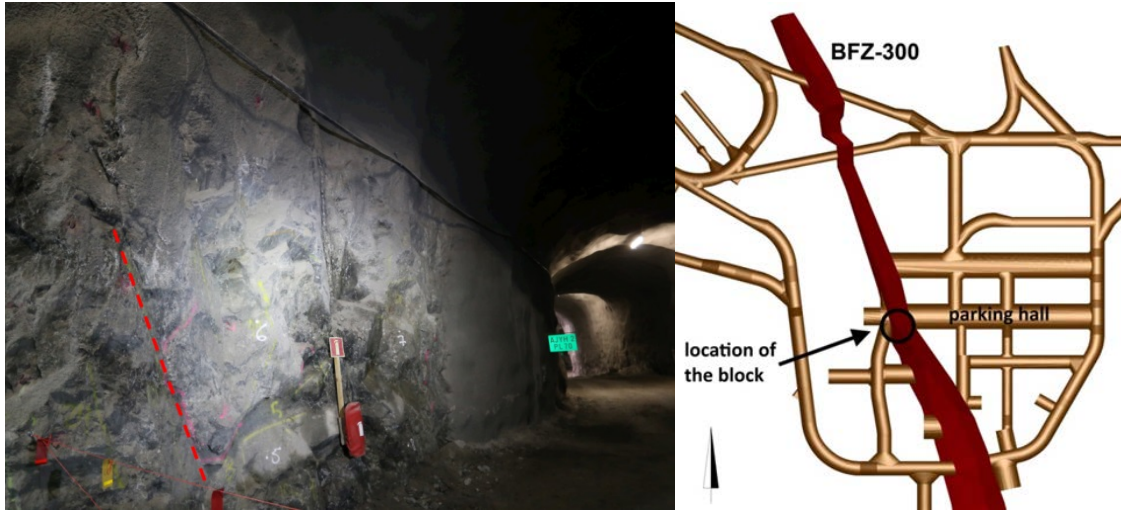
**Figure 2-2.** Test area before the experiment (right) and the location of the test block (left). The loose block is delimited by a fracture on its left side (red dashed line).

The targeted fracture for the PUSH test is a steep dipping fracture surface located behind a daylighted rock block in the southwestern corner of the ONKALO Parking Hall, indicated in Figure 2-1 and Figure 2-2. An overview of the test block and experiment setup is illustrated in Figure 2-3.

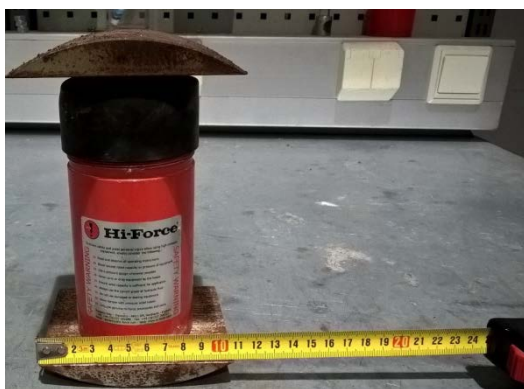
**Figure 3-3.** Jack baseplates with a jack between them on the left, baseplate dimensions in millimeters on the right.

After installation of the LVDT sensors two hydraulic jacks (Figure 3-3), with an individual capacity of 25 tons, were then set into the formerly drilled Ø 200 mm sample holes (holes 1 and 2 in Figure 3-2) to produce the necessary shear force along the fracture surface during the execution of the experiment. Concave steel baseplates (Figure 3-3) were used to provide even surfaces for the jacks both above and below the jacks. The jacks were installed parallel to the fracture surface in order to minimize out of plane shear forces, as shown in Figure 3-4.

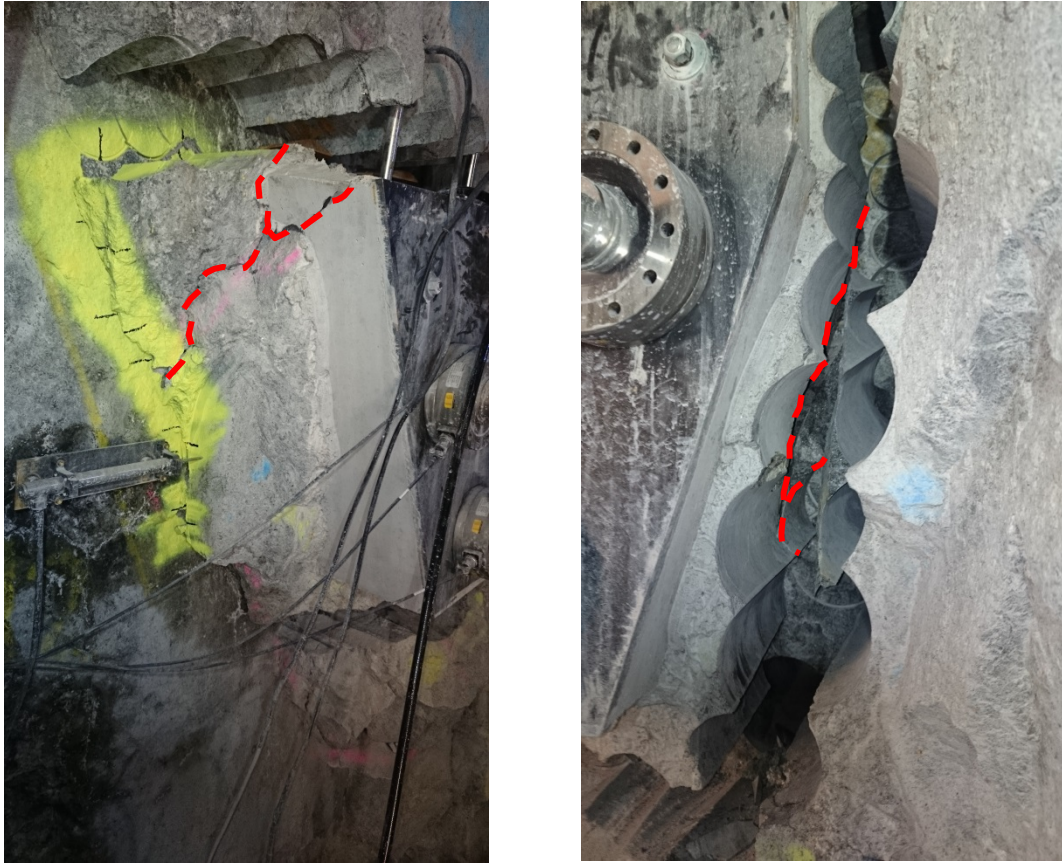
**Figure 4-3.** Observed breakages after test execution. The upper left corner broke (left) and part of the right edge broke (right). See also Figure 4-3.

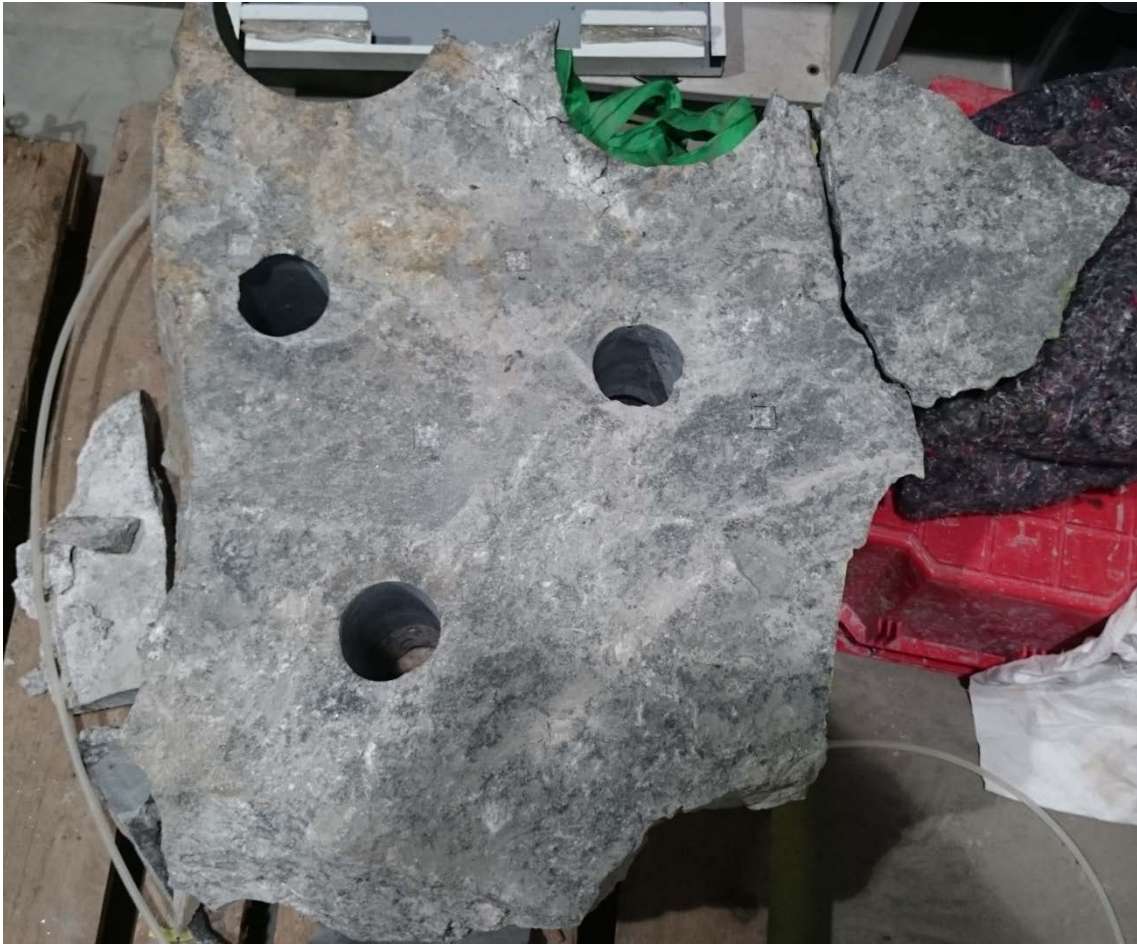
**Figure 4-4.** The fracture surface of the block along with the upper left part of the block that broke off during shear, located in the upper right part of the image. Note the smaller part that also broke off the right side of the block, located on the left side of the image.

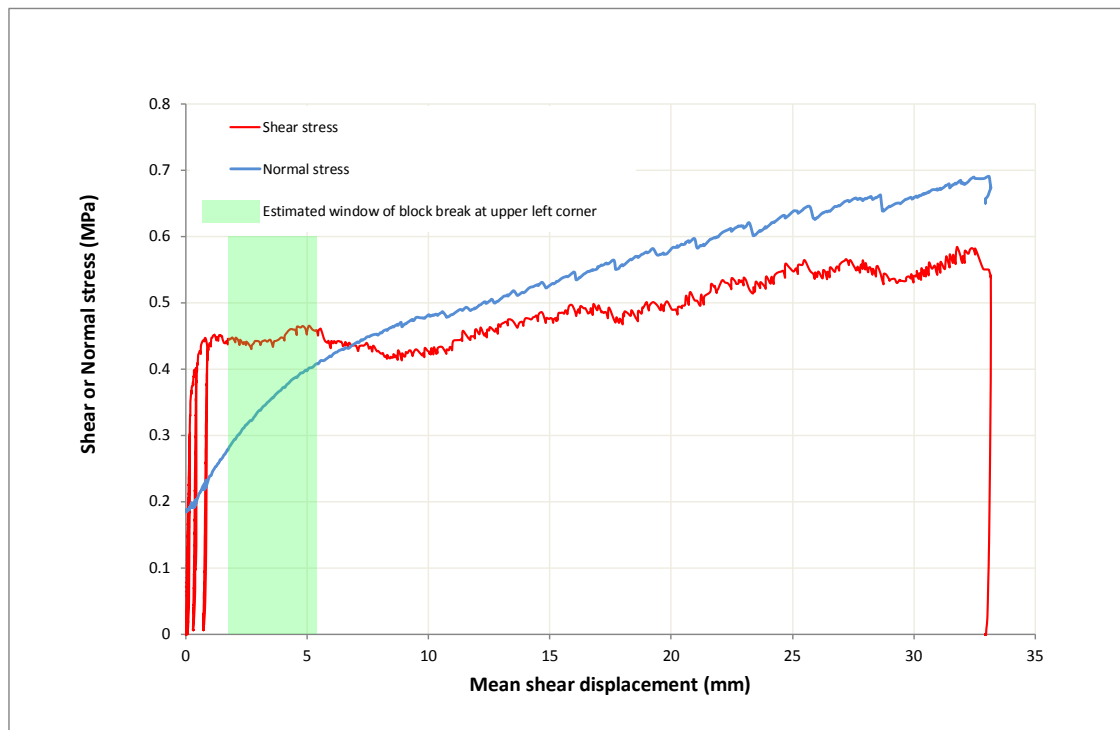
**Figure 5-5.** Shear and normal stress in MPa vs. mean shear displacement, based on the estimated fracture surface area ( $0.319 \text{ m}^2$ ) and combined jack/bolt forces. The estimated window of time for which the test block develops a fracture in the upper left corner is indicated by a shaded green area.

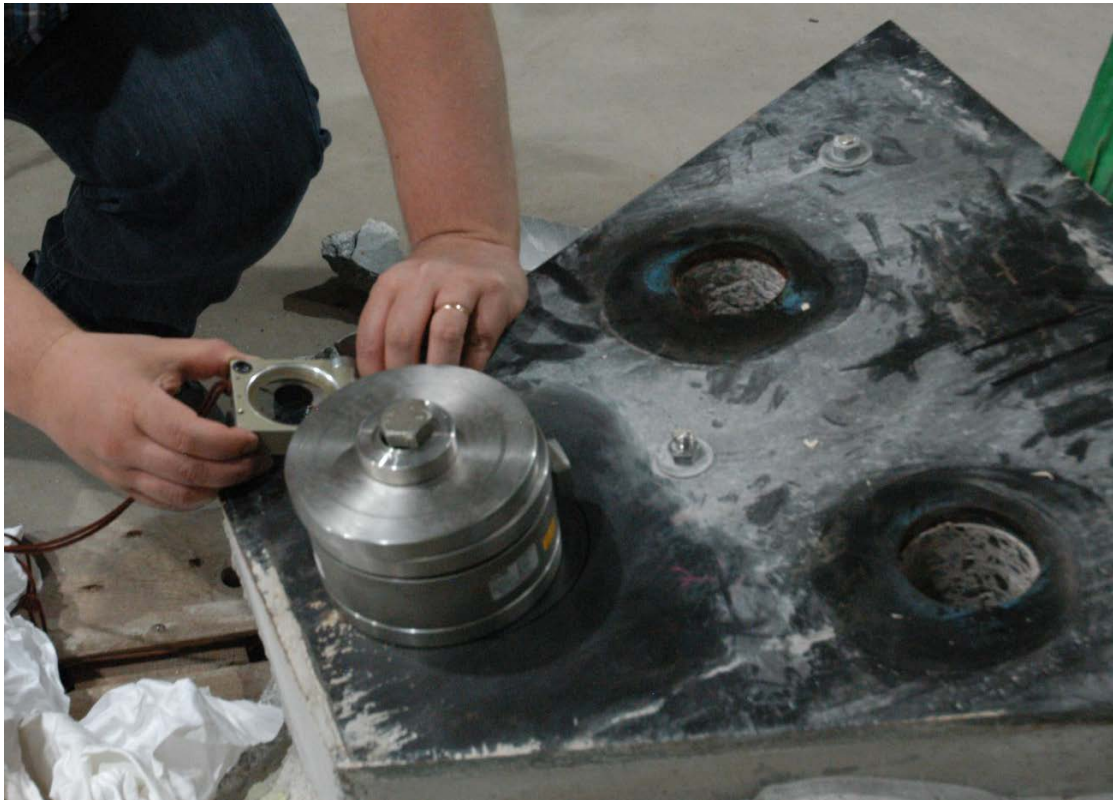
**Figure 5-7.** Tilt testing of the bolt faceplate and steel plate interface. Note that tilt testing was performed with extra bolt faceplates on top of the original faceplate and load cell configuration so as to minimise adhesion of the lubricant used between the steel plate and the bolt faceplate.

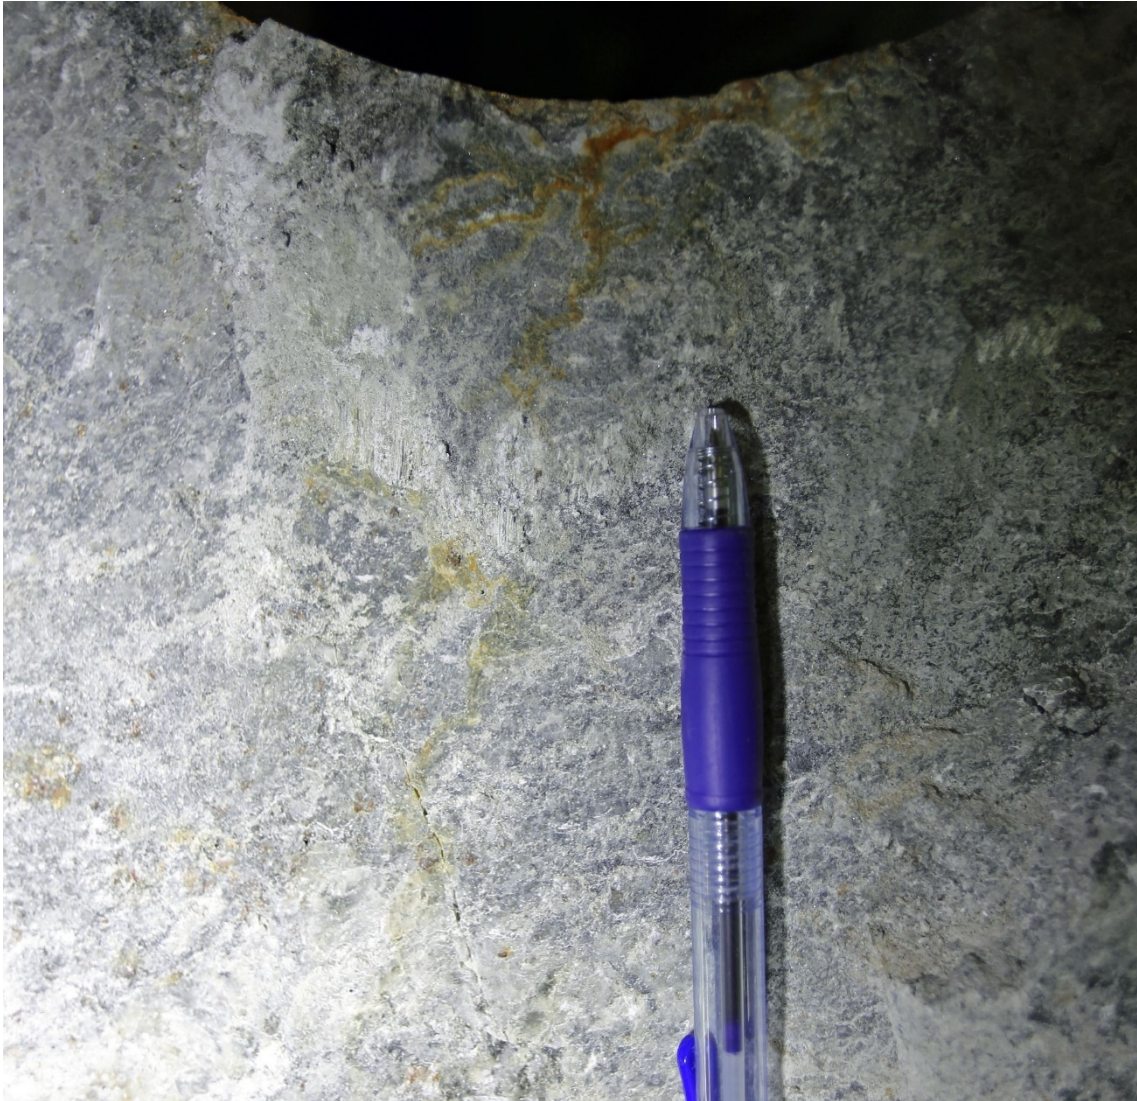
**Figure 5-10.** *An example of a sheared area that exhibited a clear slickenside surface.*
